ASTM PHASE I ENVIRONMENTAL SITE ASSESSMENT
THELAB BERKELEY
BERKELEY, CALIFORNIA

by
Haley & Aldrich, Inc.
Walnut Creek, California

for
SteelWave, LLC
San Francisco, California,

File No. 0134361-005
February 2021

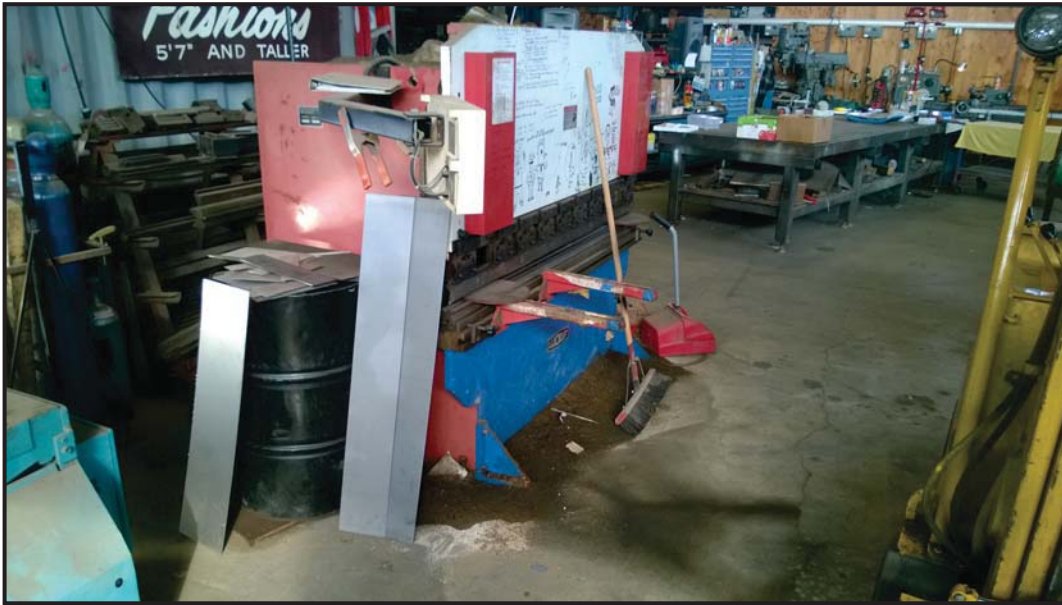
Oil staining around base of machinery.

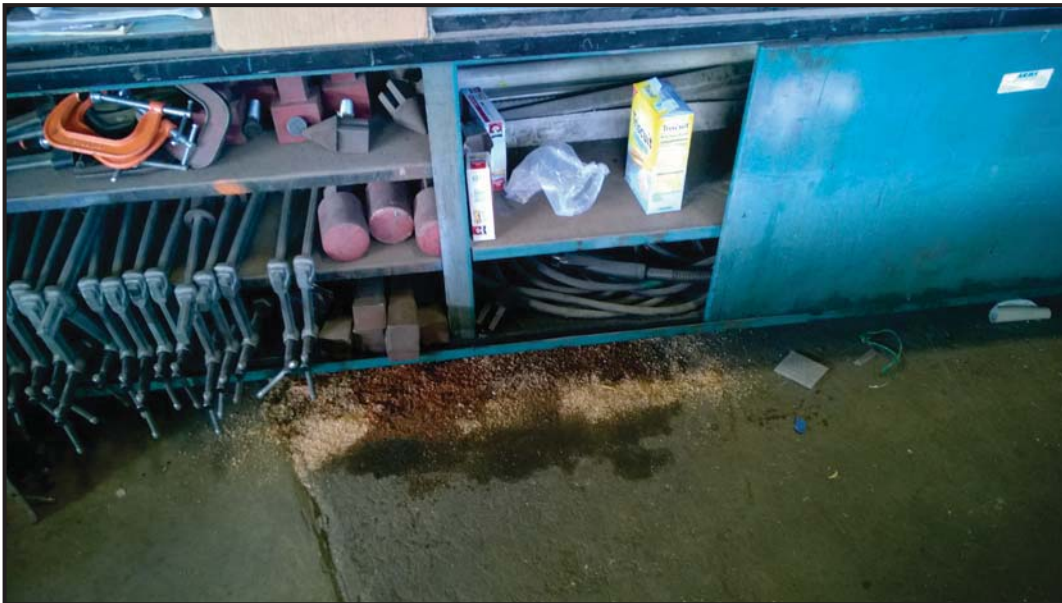
Oil staining around base of work bench.

Note: Pictures taken during a site reconnaissance on 20 February 2015.

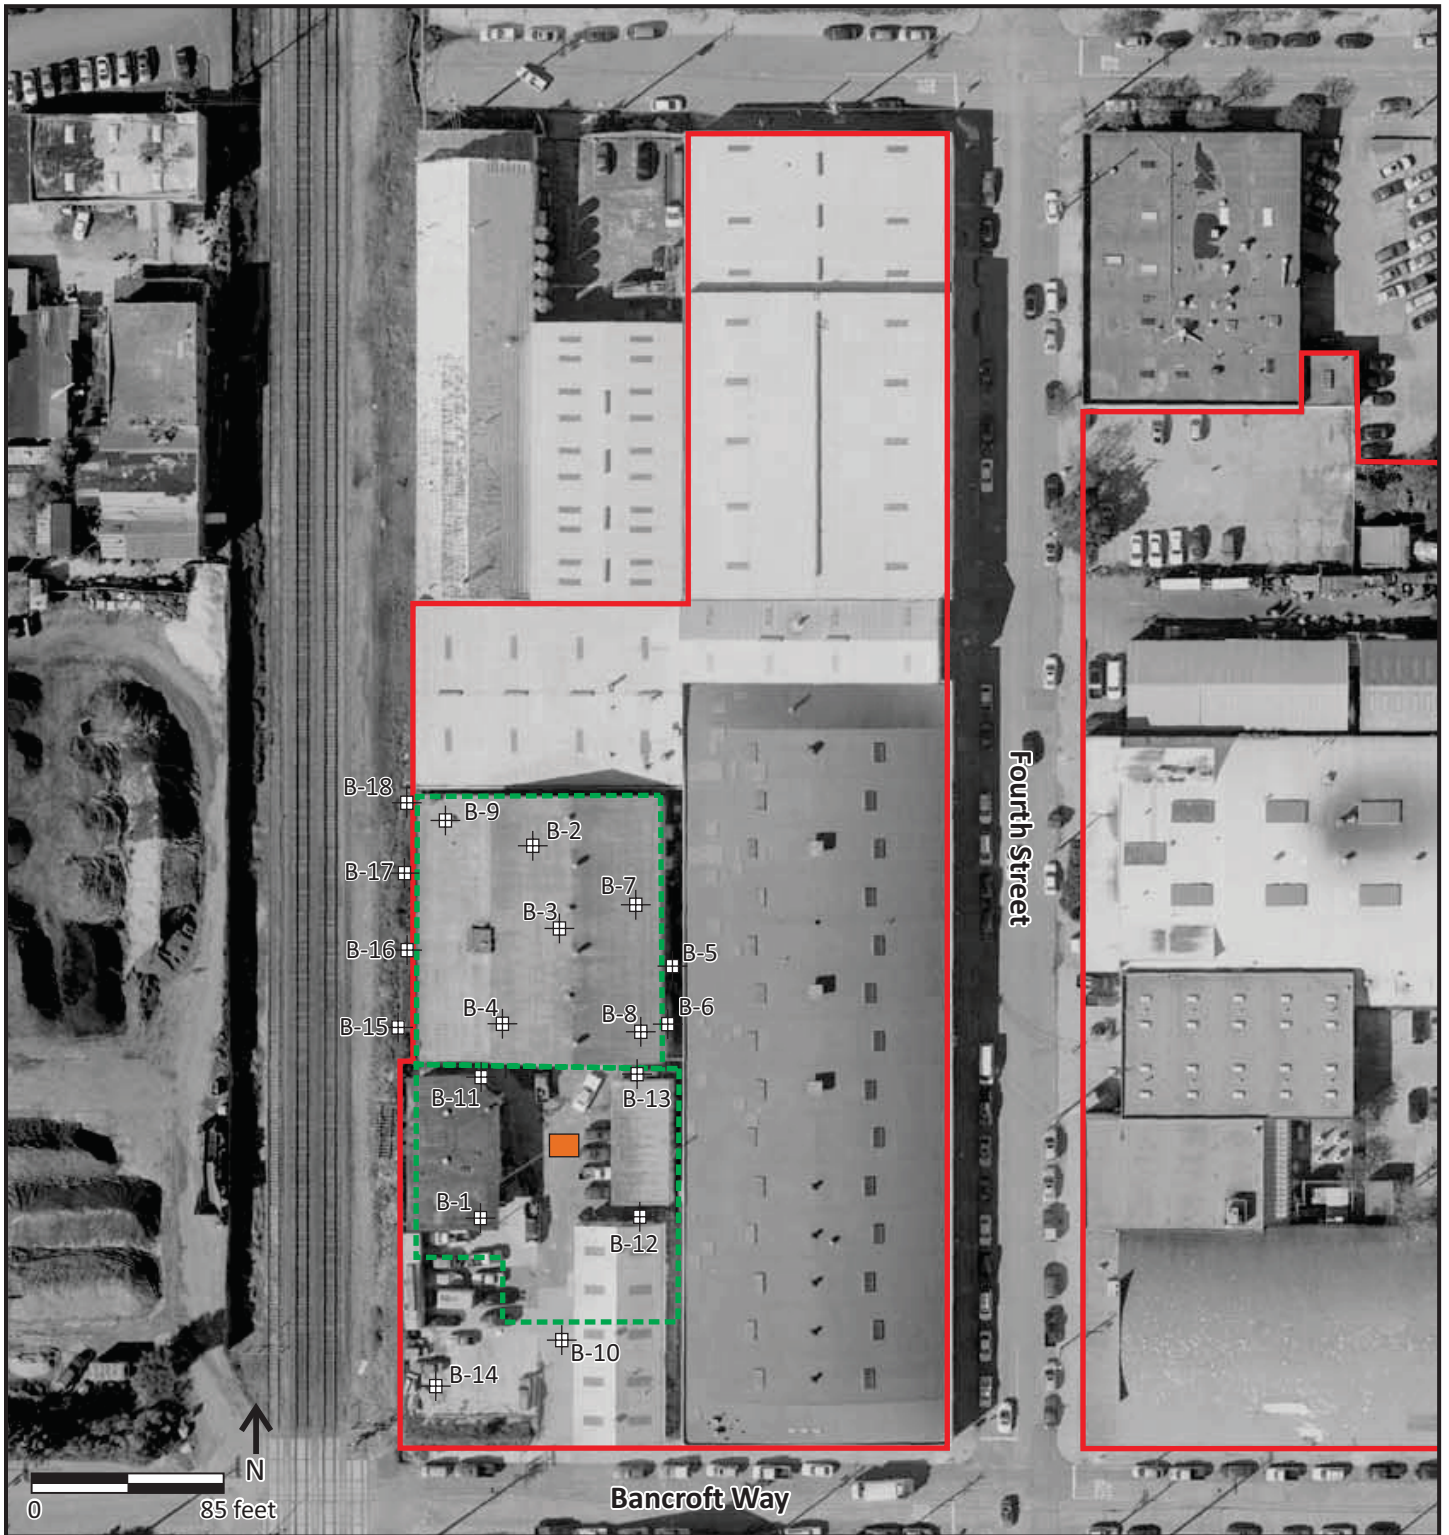
Legend

- Project Site
- Approximate Locations of Former Foundries¹
- Approximate Location of Former UST
- + Boring Location
